**Final Environmental Baseline Survey
CERFA Report
Sierra Army Depot Reuse Parcels
Lassen County, California**

Harding Lawson Associates

**Final
Environmental Baseline Survey
CERFA Report
Sierra Army Depot, Lassen County, California**

HLA Project No. 32100 11.05.01

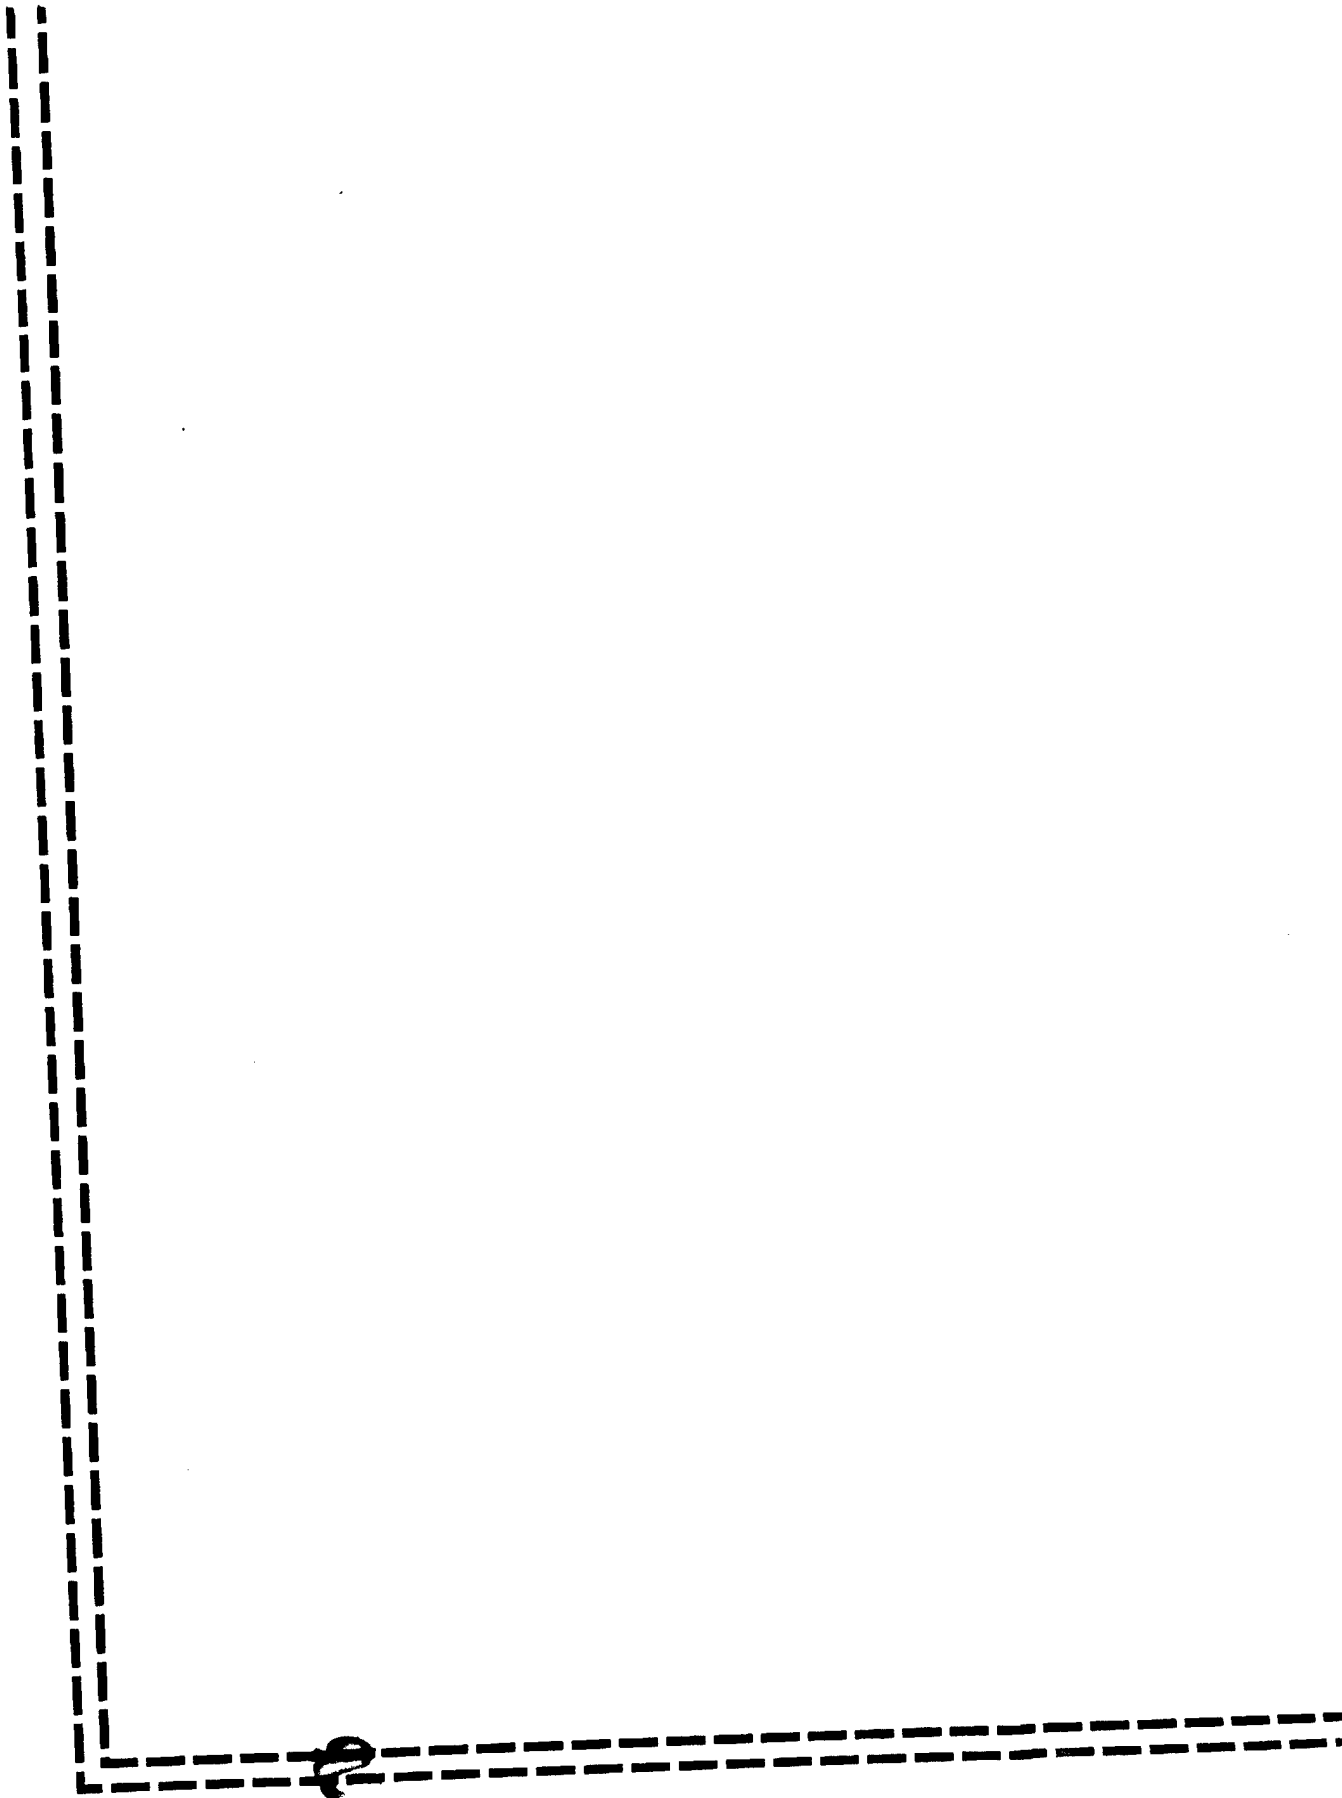
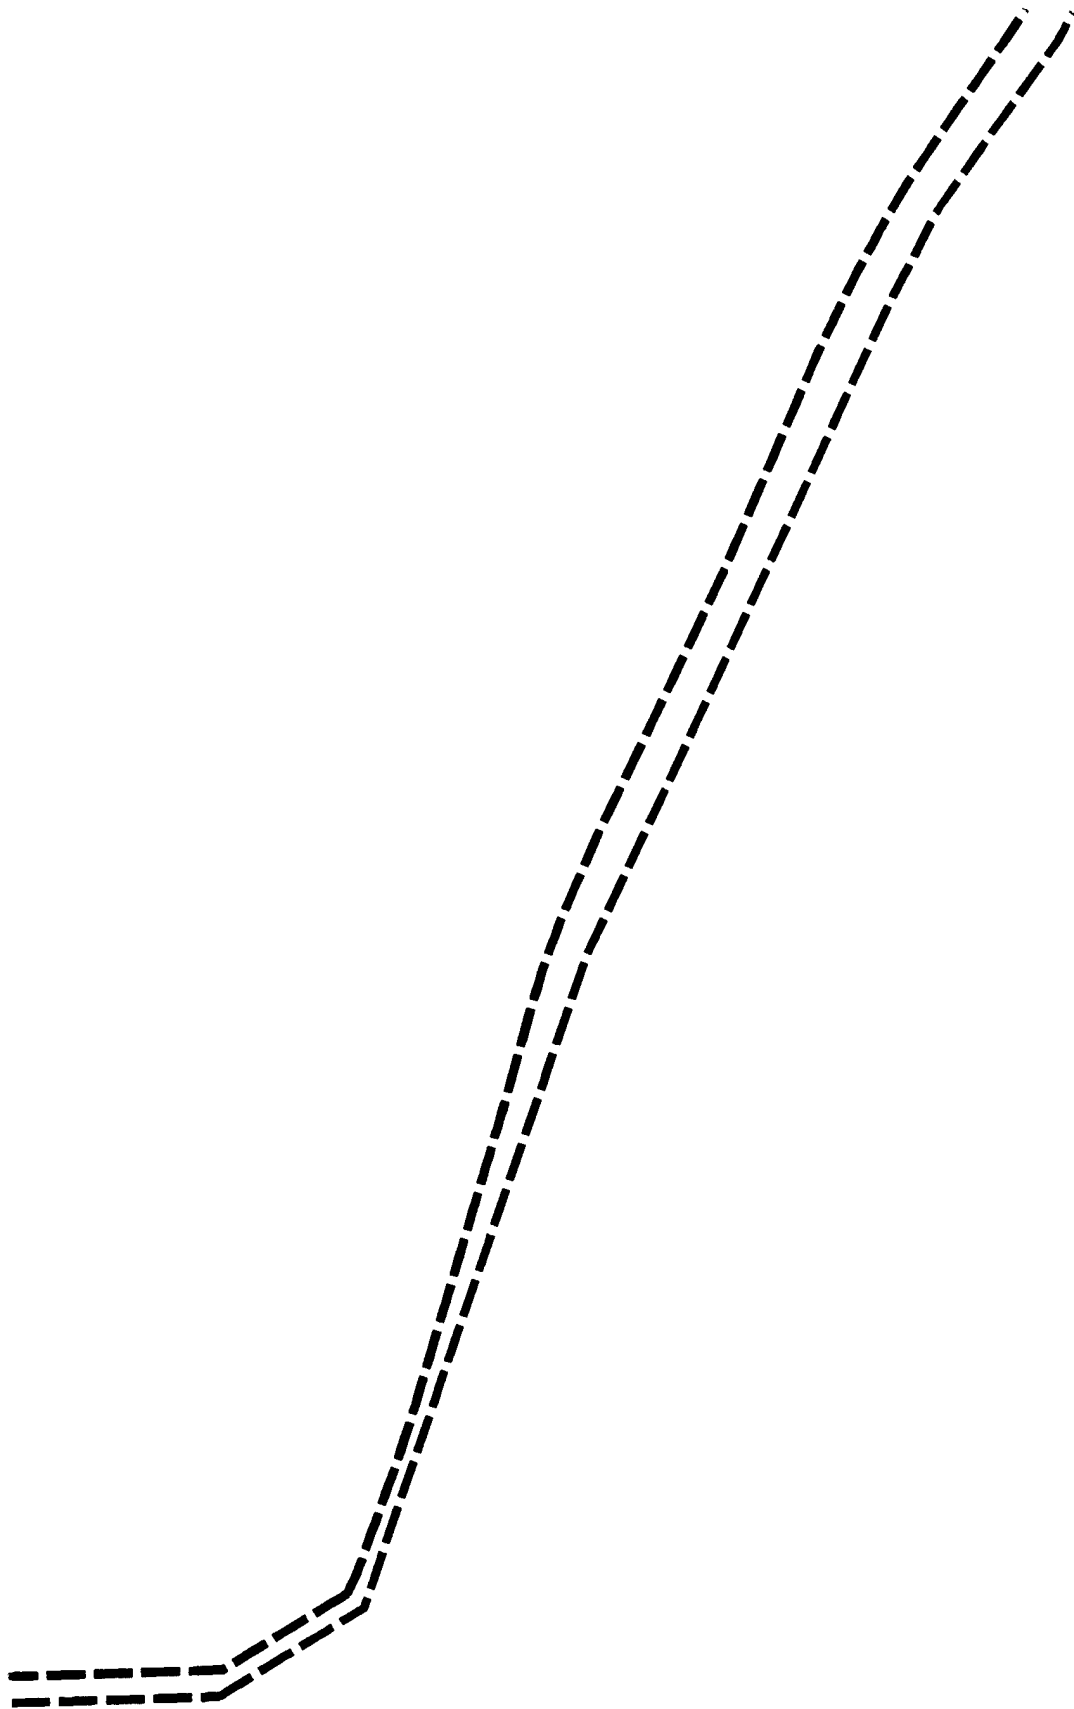
PLATE
7

Known existing transformers within the Herlong parcel. Levels of PCB-containing fluids were tested in each individual transformer and found to be below 5 ppm.

- Releases of petroleum hydrocarbons have been reported for few of the existing USTs and ASTs on the Herlong Parcel; those areas exceeding regulatory concern have been depicted as Category 7 on Plate 7. Those locations where releases have not occurred but storage has occurred are depicted on Plate 7 as Category 2. Details regarding closure data of former USTs managed by SIAD and closure data of former USTs managed by the State of California at the schools on the Herlong Parcel were not available.

Plate 7 presents the CERFA map for the Herlong Parcel. As shown on Plate 7, the majority of the undeveloped area and part of the commercial area are considered DoD Category 1 because no storage, release, or disposal of hazardous substances or petroleum products were identified during the EBS for those areas. Other isolated areas within the commercial area of the parcel are considered DoD Category 2 because of current and/or former ASTs or USTs in those areas that have been used to store petroleum products and the presence of (current and past) PCB-containing transformers. Several former or existing Army-owned UST or AST sites within the parcel are categorized as DoD Category 3 or 7. In addition, a few State-leased UST or AST locations are categorized as DoD Category 3 or 7 due to documented release of petroleum products.

Plate 7 outlines the areas discussed above and their respective DoD Environmental Conditions. The white areas, DoD Category 1 (uncontaminated), are available for transfer under CERCLA § 120(h)(4) (Plate 7). The blue areas, DoD Category 2 (storage only), are also available for transfer under CERCLA § 120(h)(4) (Plate 7). Areas depicted as DoD Category 3 are transferable under CERCLA § 120(h)(3). Those shown as DoD Category 7 are not considered transferable at this time.

As discussed in Section 4, the area of former structures on the Herlong Parcel, outlined on Plate 7, was evaluated and found not to contain ACM or LBP in the soil. Accordingly, these areas have been classified as DoD Category 7 and are currently transferable and CERCLA § 120(h)(4).

Agreed. Plates A-1, B-1, C-1, and 7 have been revised accordingly. In response to this comment, Plates A-1, B-1, and C-1 now show the tank area in the Airstrip Parcel to be classified as Category 7. For Plate 7, UST-5 has been reclassified as CERFA Category 3 while ASTs A, B, and 1203 and UST-68 remain classified as CERFA Category 7.

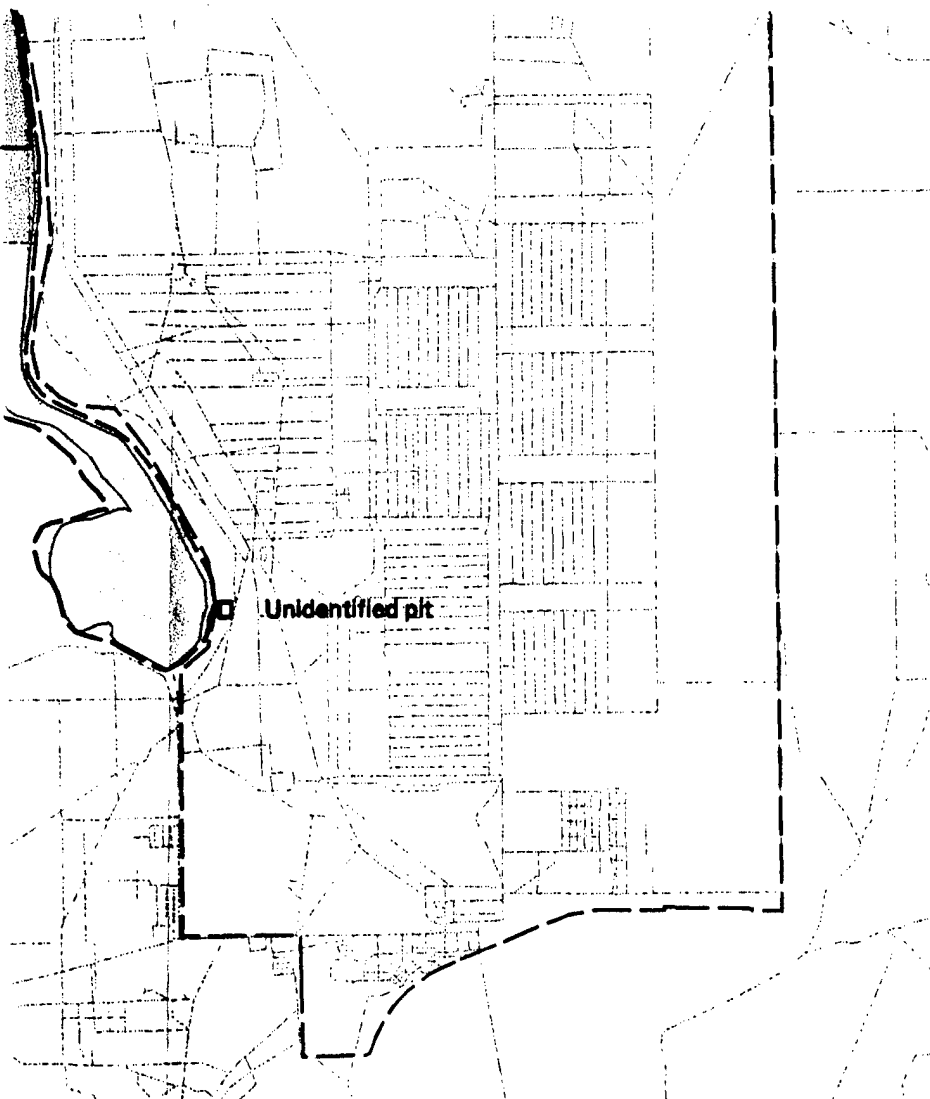
Note: Of the 60,108 acres comprising the Honey Lake Parcel, 55,241 acres have been classified as CERFA Category 3 due to the potential release of lead from bullets reported to have been strafed into the lake bed.
